**Report on the grounding of the
yacht “Woteva” on the
8th October 2011.**

David Pescud

Background

Woteva is a TP52 Class yacht currently owned by Sailors with disAbilities. She was competing in the Flinders Islet race as part of the Blue Water Point score run by the Cruising Yacht Club of Australia.

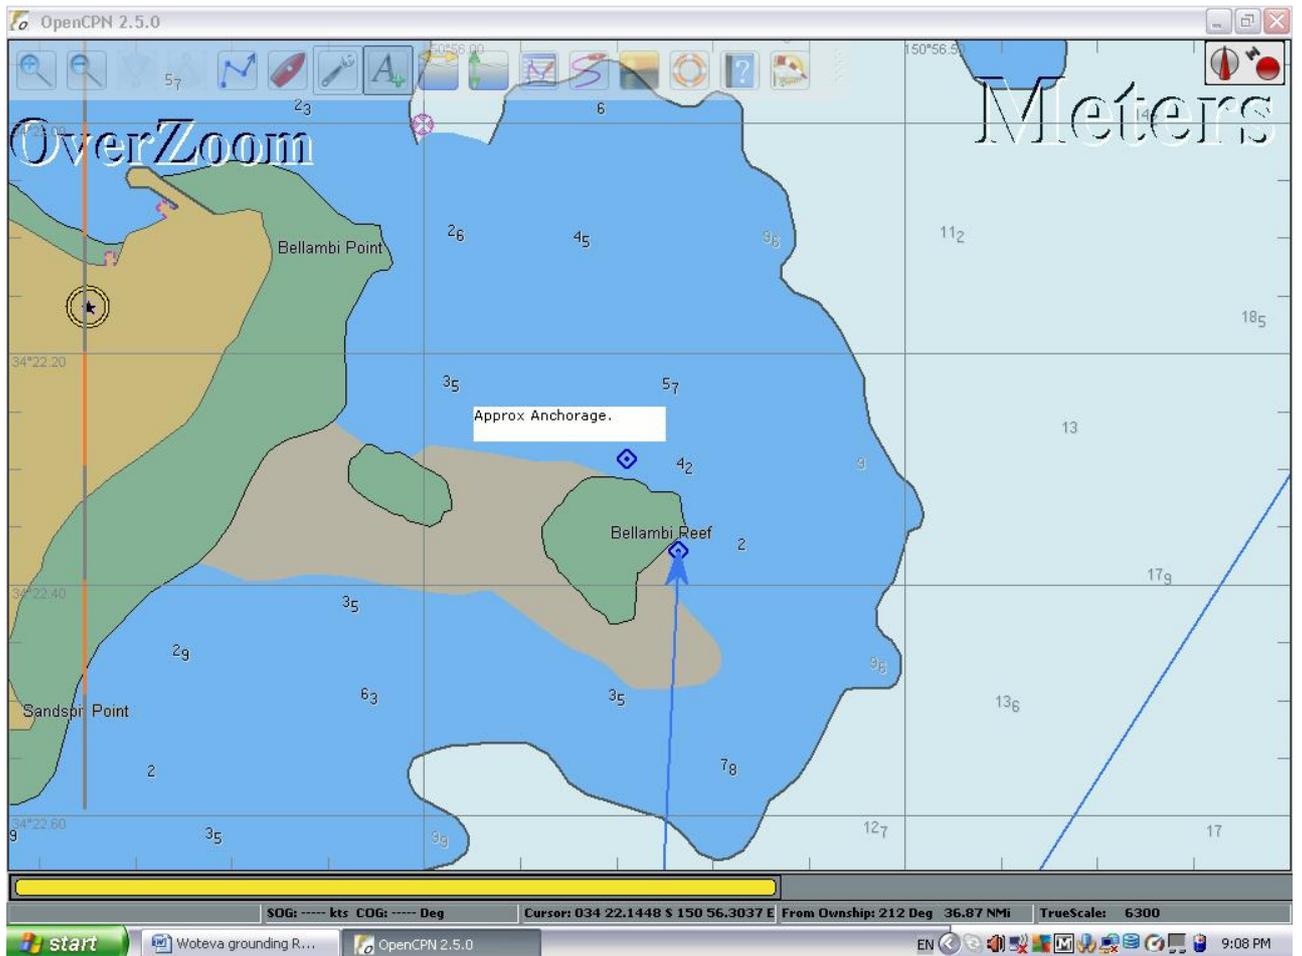
Appendix-1

Map shows approximate course of Woteva from Flinders Islet and approximate impact point. It was endeavored to show the anchor point after Woteva exited the reef.

Appendix 1 will show a map of Bellambi Reef which show's the approximate approach, approximate grounding and subsequent wash into smooth water and anchoring.
